Manhole Inspection Summary

Manhole # S69M__019MH

Insp Date: **1/29/08 9:15 AM**

Location Address: **6700 Graceland Ave.**

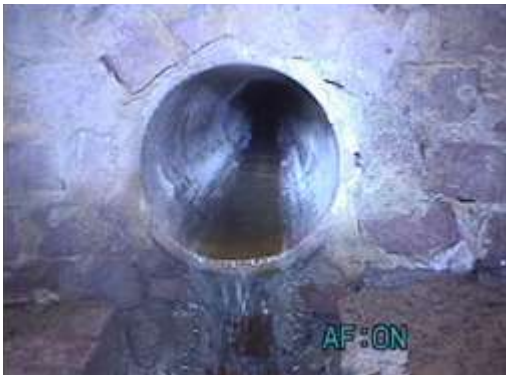
Defect 1

cracked pipe seal 10:00-2:00 on incoming
6 o'clock

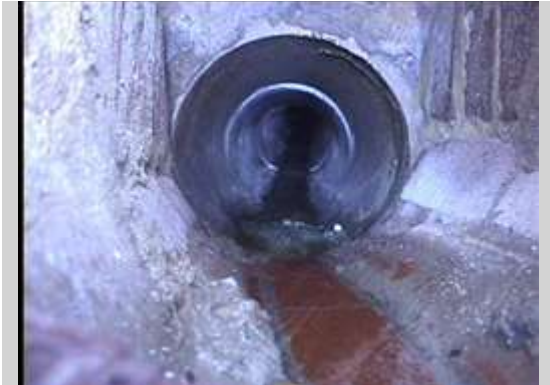
12 O'Clock Outflow

8 in. Circular Gravity Sewer
Pipe Out @ 12 O'Clock

Pipe Height: **8.4** (in.) Rod and Bar (Angled)
Pipe Material: **Clay** ☐ Pipe Lined
Invert Depth: **7.71** (ft.) Flow Characteristics: **Slow**
Deposits: ☒ None ☐ Mud ☐ Sludge ☐ Debris ☐ Grease
Silt Depth: (in.) Deposits Extent:
Infiltration: **None** Pipe Seal Cond: **Sound**

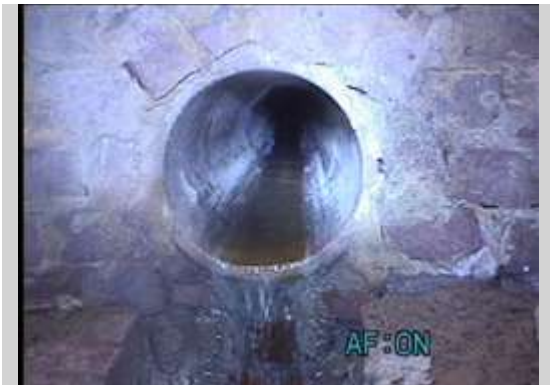
6 O'Clock Inflow

8 in. Circular Gravity Sewer
Pipe In @ 6 O'Clock

Pipe Height: **8.4** (in.) Rod and Bar (Angled)
Pipe Material: **Clay** ☐ Pipe Lined
Invert Depth: **6.71** (ft.) Flow Characteristics: **Fast**
Deposits: ☒ None ☐ Mud ☐ Sludge ☐ Debris ☐ Grease
Silt Depth: (in.) Deposits Extent:
Infiltration: **None** Pipe Seal Cond: **Cracked**
